NASA Contractor Report 165733

Flight Service Evaluation of Kevlar-49 Epoxy Composite Panels in Wide-bodied Commercial Transport Aircraft

Seventh Annual Flight Service Report

LOCKHEED-CALIFORNIA COMPANY
BURBANK, CALIFORNIA

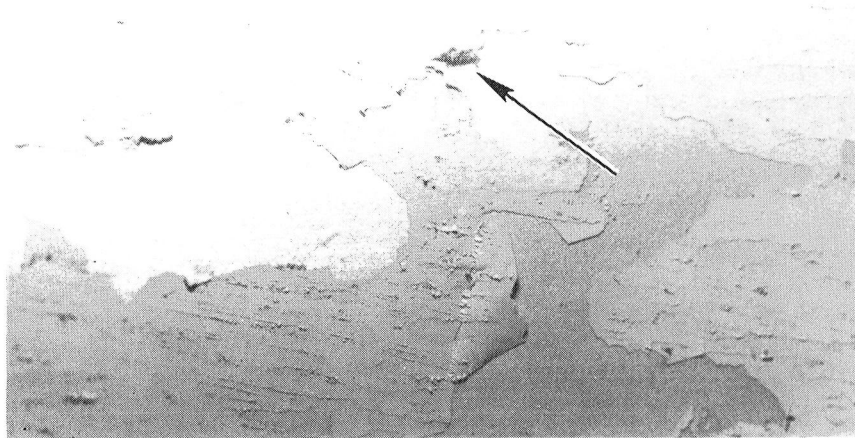
1. A deep gouge in the upper center area of the panel exterior, 0.4- by 0.6- cm (5/32- by 1/4-inch), had not changed in size or appearance since the previous inspection (Figure 4). This was first observed in 1978.

Figure 4. - Air Canada Left-Hand Wing-Body Fairing -
Deep Gouge 0.4 by 0.6 cm (5/32 by 1/4 in.).

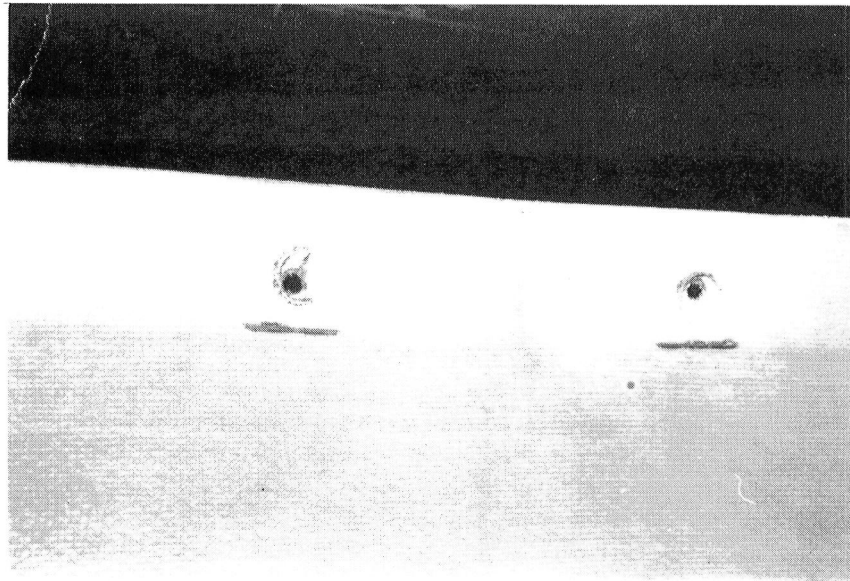
Figure 6. - Air Canada Left-Hand Wing-Body Fairing - Fastener Holes on Lower Edge with Mark-off.

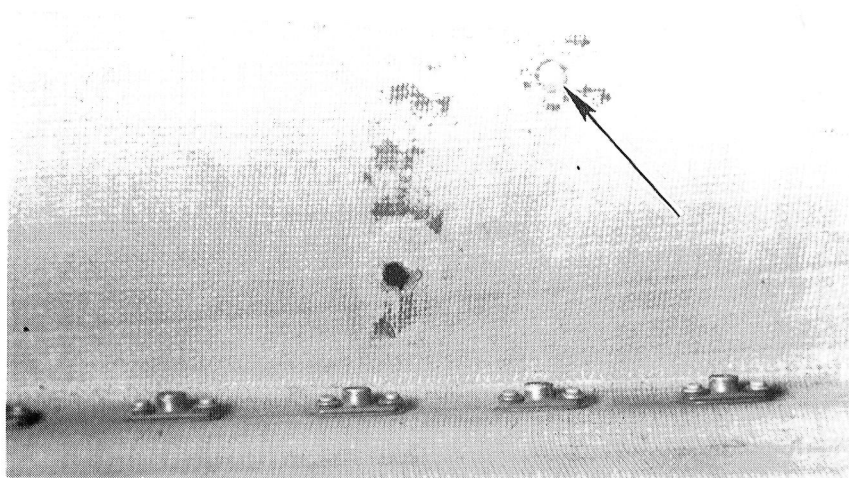
1. No surface damage or defects were noted, although there was extensive paint loss, particularly in the upper section where the Kevlar-49 was almost completely exposed. The location of this part protects it from ultraviolet exposure however.
2. Slight fraying was observed on all fastener holes, and several holes were observed to be frayed to a greater extent than the others. Most of the fastener holes had at least a slight degree of elongation, and eight holes had a significant degree of elongation to 0.55 cm (7/32 in.) and in three cases to 0.6 cm (1/4 in.) from the original 0.5 cm (3/16 in.) dimension (Figure 7).

Figure 7. - Air Canada Left-Hand Underwing Fillet With Elongated Hole and Slight Fraying.

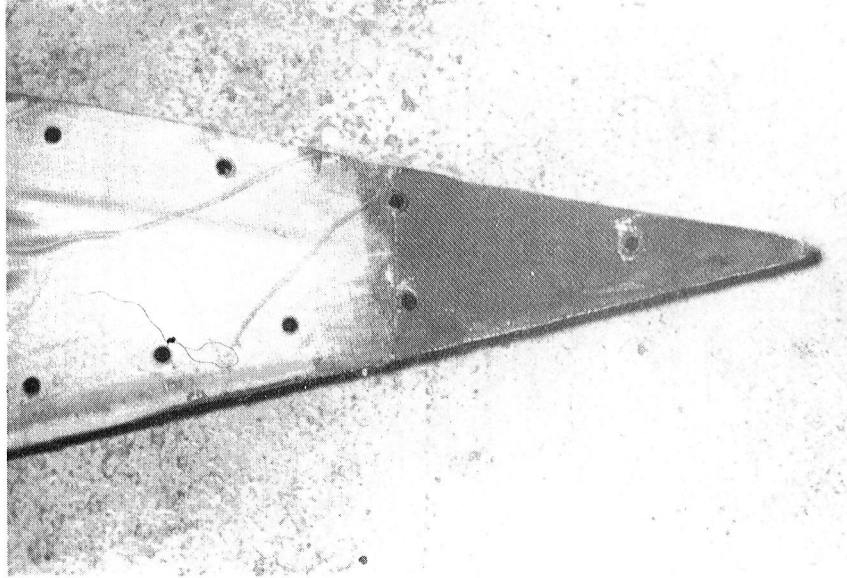
1. No damage or defects were noted on either surface, but there was extensive paint loss indicating possible Skydrol exposure.
2. Two patch areas at the extreme forward and aft edges of the fairing were still unchanged in appearance since 1974 when they were originally observed. The patches are dark and fibrous, and may be some type of electrical tape overcoated with resin (Figure 8).

Figure 8. - Air Canada Right-Hand Aft Engine Fairing -
Patched Area at Forward End.

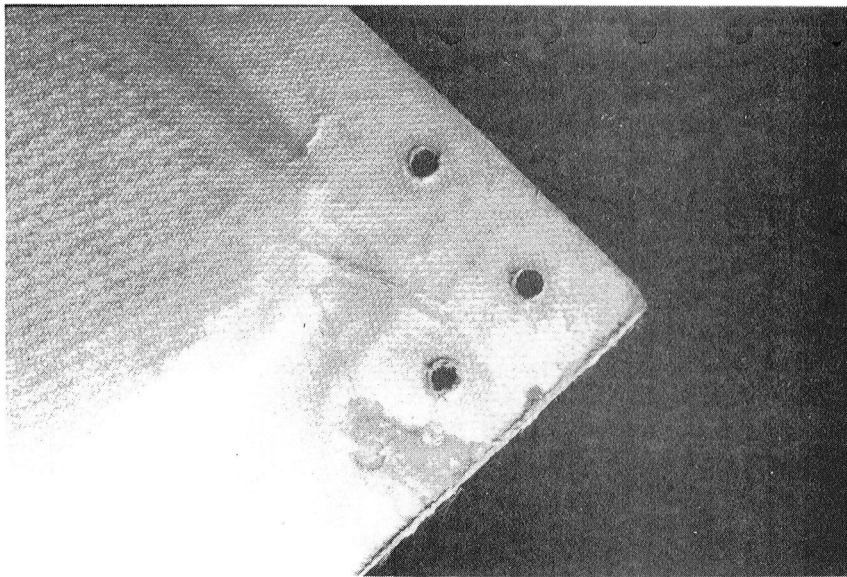
3. Slight fraying was observed on all fastener holes, but the degree of fraying on this component is less than that noted on any of the other Kevlar-49 aft engine fairings. About 1/3 of the fastener holes are noticeably more frayed than the other holes (Figure 9).
4. Several holes had a slight amount of elongation. Two holes were elongated to 0.55 cm (7/32 in.) from the original 0.5 cm (3/16 in.) diameter, and two holes were badly elongated to 0.7 (9/32 in.) diameter (Figure 10). This was out of approximately 100 fastener holes on the aft engine fairing, so the incidence of hole elongation was very minor.

Figure 9. - Air Canada Right-Hand Aft Engine Fairing -
Typical Fastener Holes.

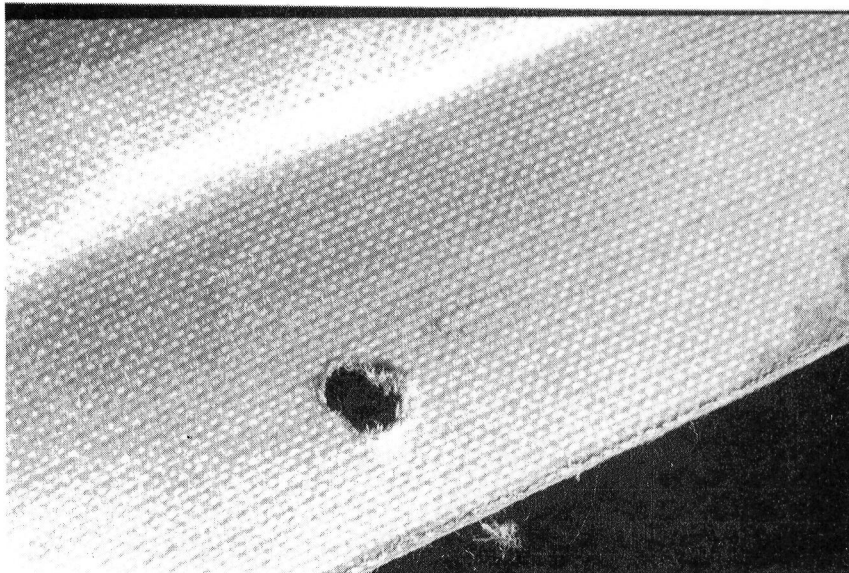
Figure 10. - Air Canada Right-Hand Aft Engine Fairing -
Badly Elongated Hole.

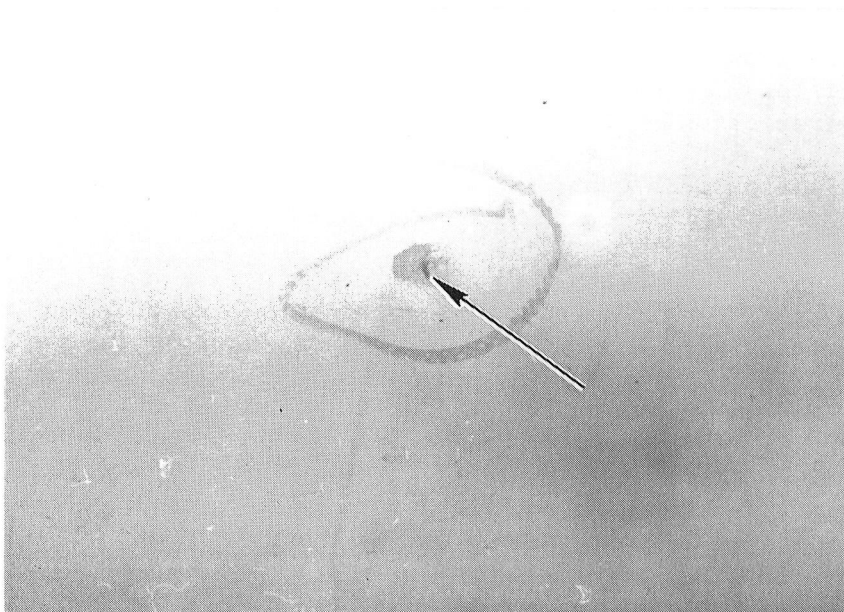
1. Two exterior surface cracks observed in earlier inspections had not propagated or changed in appearance. These were a deep 0.3 cm (1/8 in.) crack in the center area first observed in 1976, (Figure 11) and a 0.6 cm (1/4 in.) crack in the forward center area first observed in 1975. There were no other exterior surface defects or damage. The 0.3 cm crack had been circled by Air Canada Maintenance.

Figure 11. - Air Canada Right-Hand Aft Wing-Body
Fairing - 0.3 cm (1/8 in.) Crack.

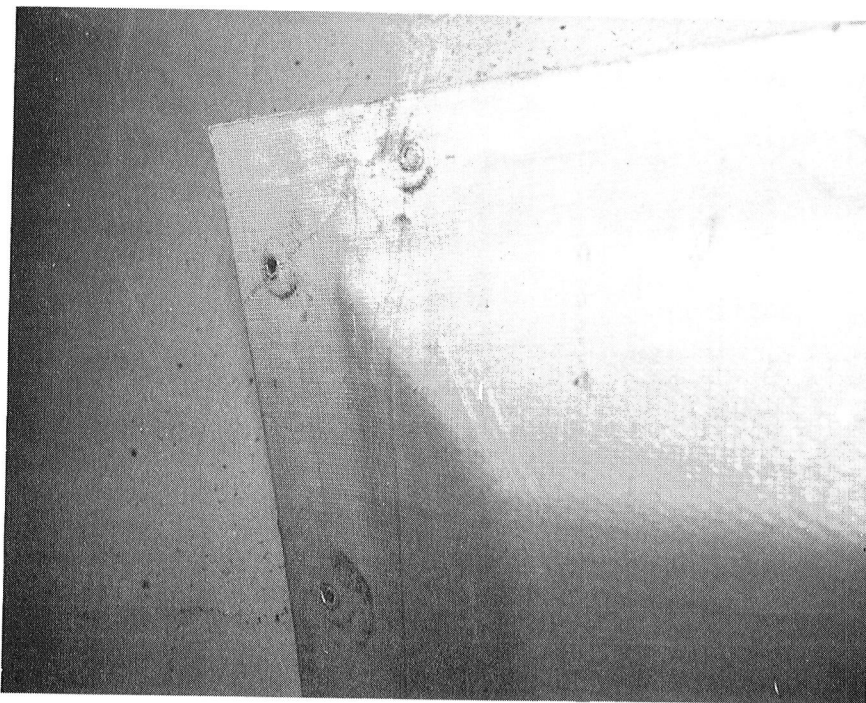
4. Fraying was observed on most of the fastener holes to a slight degree (Figure 12). Fraying was more pronounced on the aft edge than the top and forward edges; but the lower edge had the greatest degree of fraying, with the five aft holes very badly frayed.

Figure 12.— TWA Right-Hand Wing-Body Fairing - Typical Fastener Holes With Slight Fraying.

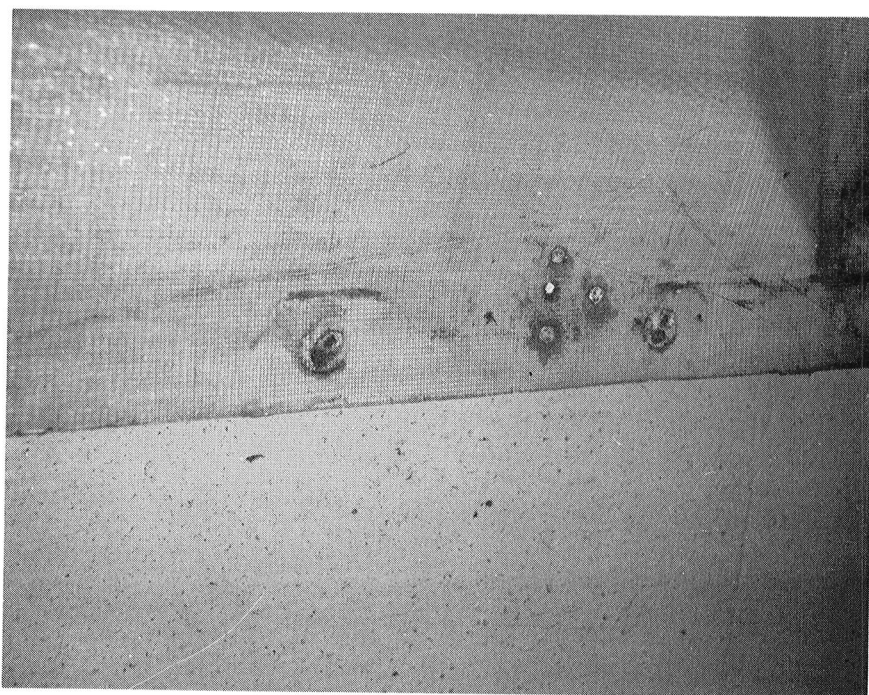
5. Several holes showed some degree of elongation, and 11 of these were on the aft and lower edges. Six holes were elongated to 0.55 cm (7/32 in.) from the original 0.5 cm (3/16 in.) diameter, and six were elongated to 0.6 cm (1/4 in.) diameter. Two of the elongated holes on the lower edge had been relocated at the time of reinstallation (reference 3), and the new holes had been drilled partially through a glass-filled resin filler. Fastener mark-off around the holes was noted to a slight degree on the upper, forward and aft edges; and to a significantly greater degree on the lower edge (Figure 13). This condition had not changed since the 1978 inspection. A bolted metal attachment (Figure 13) appears to be for drainage purposes and is not a repair.

Figure 13.— TWA Right-Hand Wing-Body Fairing - Fastener Holes On Lower Edge With Mark-off (Also Showing Drainage Attachment).

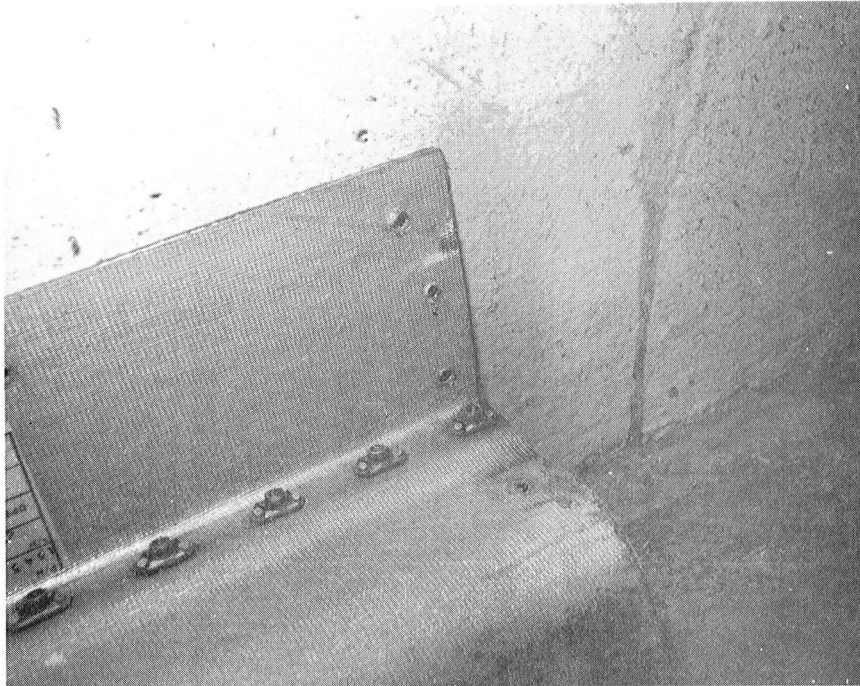
2. No surface damage or defects were observed, but Skydrol was observed on the surface.
3. All of the fastener holes showed at least a slight degree of fraying, and eight were badly frayed (Figure 14). Eight of the holes had a significant degree of elongation, six of these to a 0.55 cm (7/32 in.) dimension and two to a 0.6 cm. (1/4 in.) dimension from the original 0.5 cm. (3/16.) diameter. Five holes had both the heavy fraying and significant elongation, but the two conditions did not match exactly.

Figure 14. - TWA Right-Hand Underwing Fillet -
Fasteners Holes With Fraying.

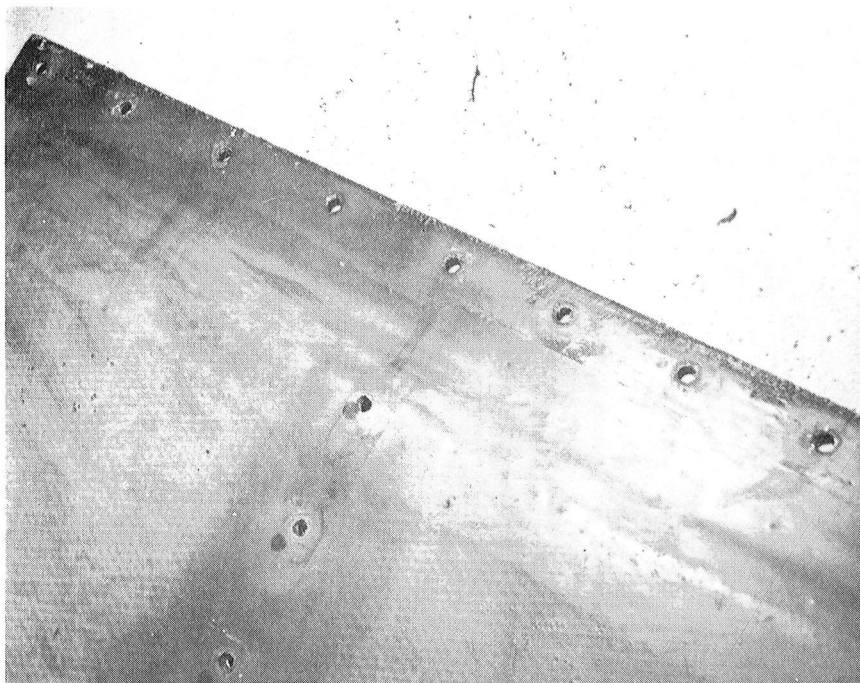
2. The fastener holes showed very little fraying (Figure 15). All of the fastener holes were redrilled when this part was reinstalled (reference 2), and the drilling was performed after curing an outer layer of 120 fiberglass over both Kevlar-49 surfaces. The glass completely prevents the typical frayed condition of Kevlar-49 fastener holes.
3. About 1/3 of the fastener holes showed some elongation, and a total of 29 were elongated to a significant degree. One hole was extremely elongated to 0.95 cm (3/18 in.) from the 0.5 cm (3/16 in.) diameter; 10 holes were elongated to 0.6 cm (1/4 in.) diameter, and the remaining 18 holes were elongated to 0.55 cm (7/32 in.) diameter. The distribution of these elongated holes was random.

Figure 15. - TWA Left-Hand Aft Engine Fairing -
Typical Fastener Holes.

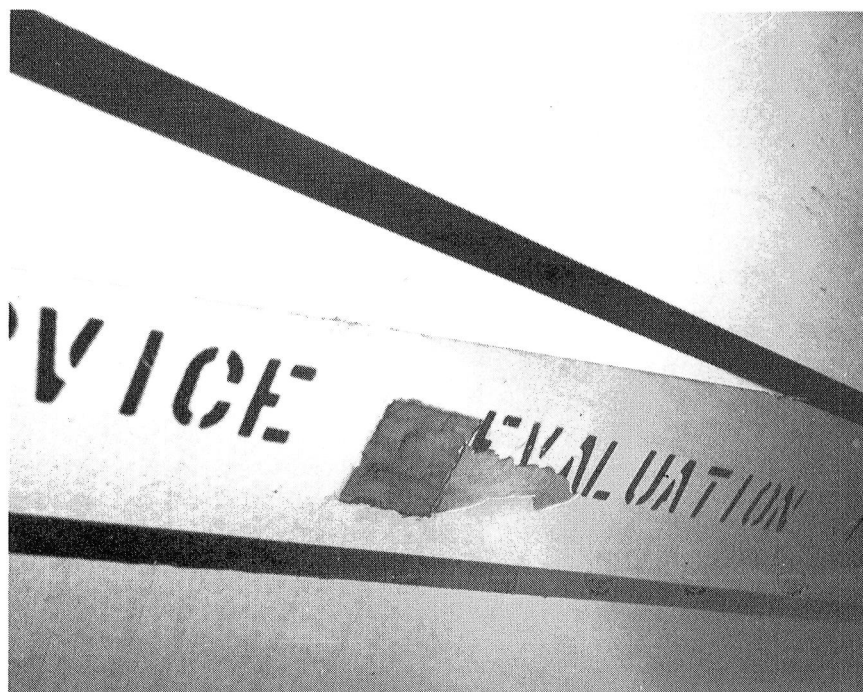
1. A deep gouge 1.3 cm (0.5 in.) in length first observed in 1978 had been repaired since the 1979 inspection by application of a tape patch (Figure 16). A crack 0.3 cm. (1/8 in.) long first observed in 1977 had also been repaired since the 1979 inspection by filling with resin. This was still detectable as a slight indentation. There were no records of these repairs.
2. Another crack 1.3 cm. (0.5 in.) in length was observed near the repaired gouge. This had not been observed previously.
3. Extensive paint loss was observed along with the presence of Skydrol.

Figure 16.- TWA Left-Hand Wing-Body Fairing
Tape Patch Repair of Gouged Area.
